Alberta Energy Regulator

Pace Oil and Gas Ltd.
Wellhead Piping Failure
Licence No. W0057420
May 19, 2012

AER Investigation Report

March 3, 2014

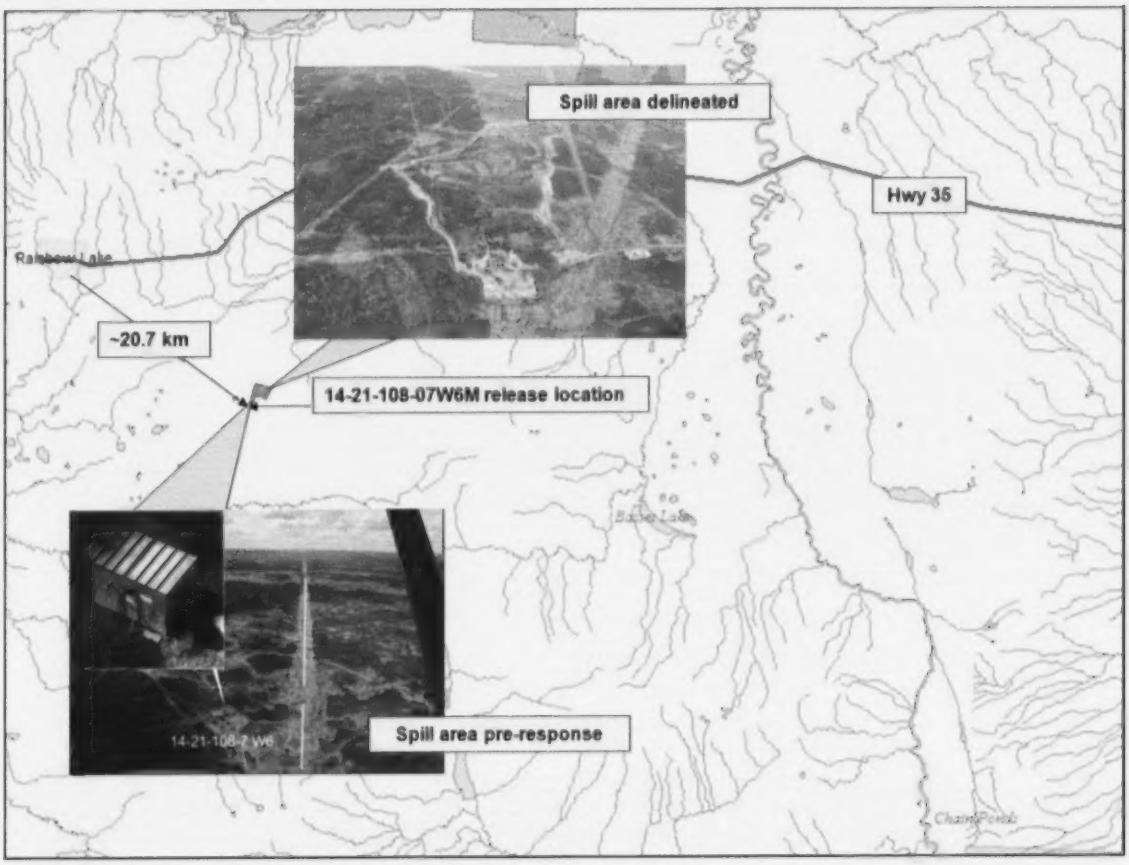
Figure 1. Pace Rainbow Lake Field spill. (Source: AER)

The spill, originating at the disposal well at LSD 14-21 (14-21 well), pooled in an unoccupied beaver dam about 40 metres (m) from the well and migrated almost 500 m downgradient from the source. The area visibly impacted by the spill extended about 475 m from the source and was about 185 m at its widest point. Pace, in consultation with the Alberta Energy Regulator (AER)[3] and Alberta Environment and Sustainable Resource Development (ESRD), estimated the total spill area to be 4.5 hectares (11 acres).

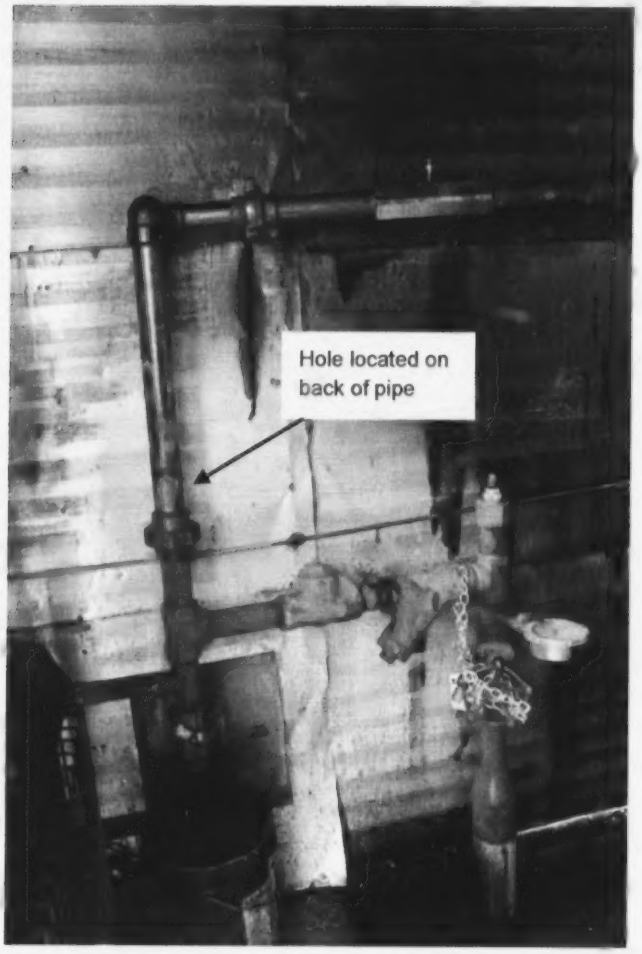
Figure 2. Lease piping prior to removal for analysis. (Source: AER)

The 14-21 wellhead pipe failure occurred on a threaded, 58 centimetre (cm), vertically oriented segment of pipe (figure 2). The through-wall perforation (hole) was about 13 mm in diameter (figure 3) and about 15 cm downstream (towards the wellhead) of an electrical isolating union.[12] Documentation supplied by Pace indicated that there were no piping modifications to the wellhead until 2009 when Provident replaced the isolating union with a non-isolating hammer union. Provident made this replacement because of a recommendation from a CP adjustive survey.[13] The failed pipe segment appears to have been originally installed in 1977 by Pacific when the well was approved for disposal operations. Produced water (about 14 000 to 18 000 ppm chlorides) is disposed of on an intermittent basis at a maximum pressure of 700 kilopascals (kPa) and a temperature of 38°C.

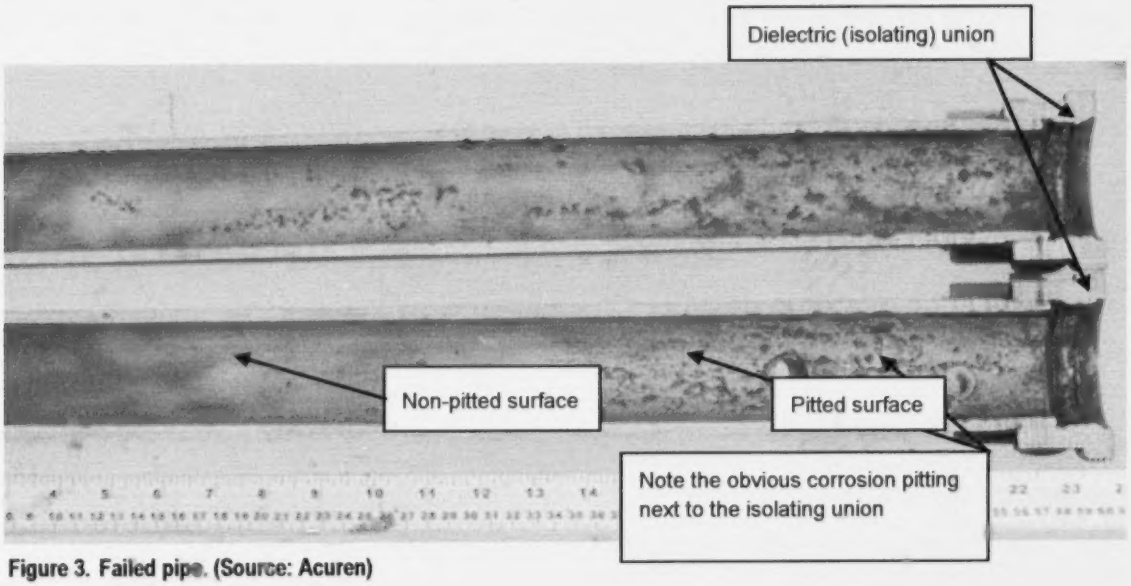
Figure 3. Failed pipe. (Source: Acuren)

The report indicated that the undiagnosed stray currents were detected at the 14-21 well casing, flowed through the wellhead piping that was isolated from the pipeline, and were discharged or "bridged" across the isolating union through the lower resistivity salt water (electrolyte). Broadsword observed elevated metal loss and pitting where the current left the pipe wall and entered the electrolyte.

The AER has reviewed the metallurgical analysis and supporting documents submitted by Pace in the reports noted above relating to the failed wellhead piping on the 14-21 well. The AER concludes that the Schedule 80,[18] 60.3 mm wellhead piping failed as a result of internal pitting corrosion initiated by stray current interference that could have been later influenced by one or a combination of the following:

The AER agrees with the analyses submitted by Pace and its consultants, which indicate that at some point during the operating history of the 14-21 well, stray current interference initiated the corrosion process, ultimately contributing to the wellhead pipe failure. This finding is supported by the obvious and abrupt internal corrosion pitting in the transition area immediately downstream of the CP isolating union.

Dielectric (isolating) union
Non-pitted surface
Pitted surface
Note the obvious corrosion pitting next to the isolating union
